New Hampshire Volunteer Lake Assessment Program

2003 Interim Report for French Pond Henniker

NHDES
Water Division
Watershed Management Bureau
29 Hazen Drive
Concord, NH 03301

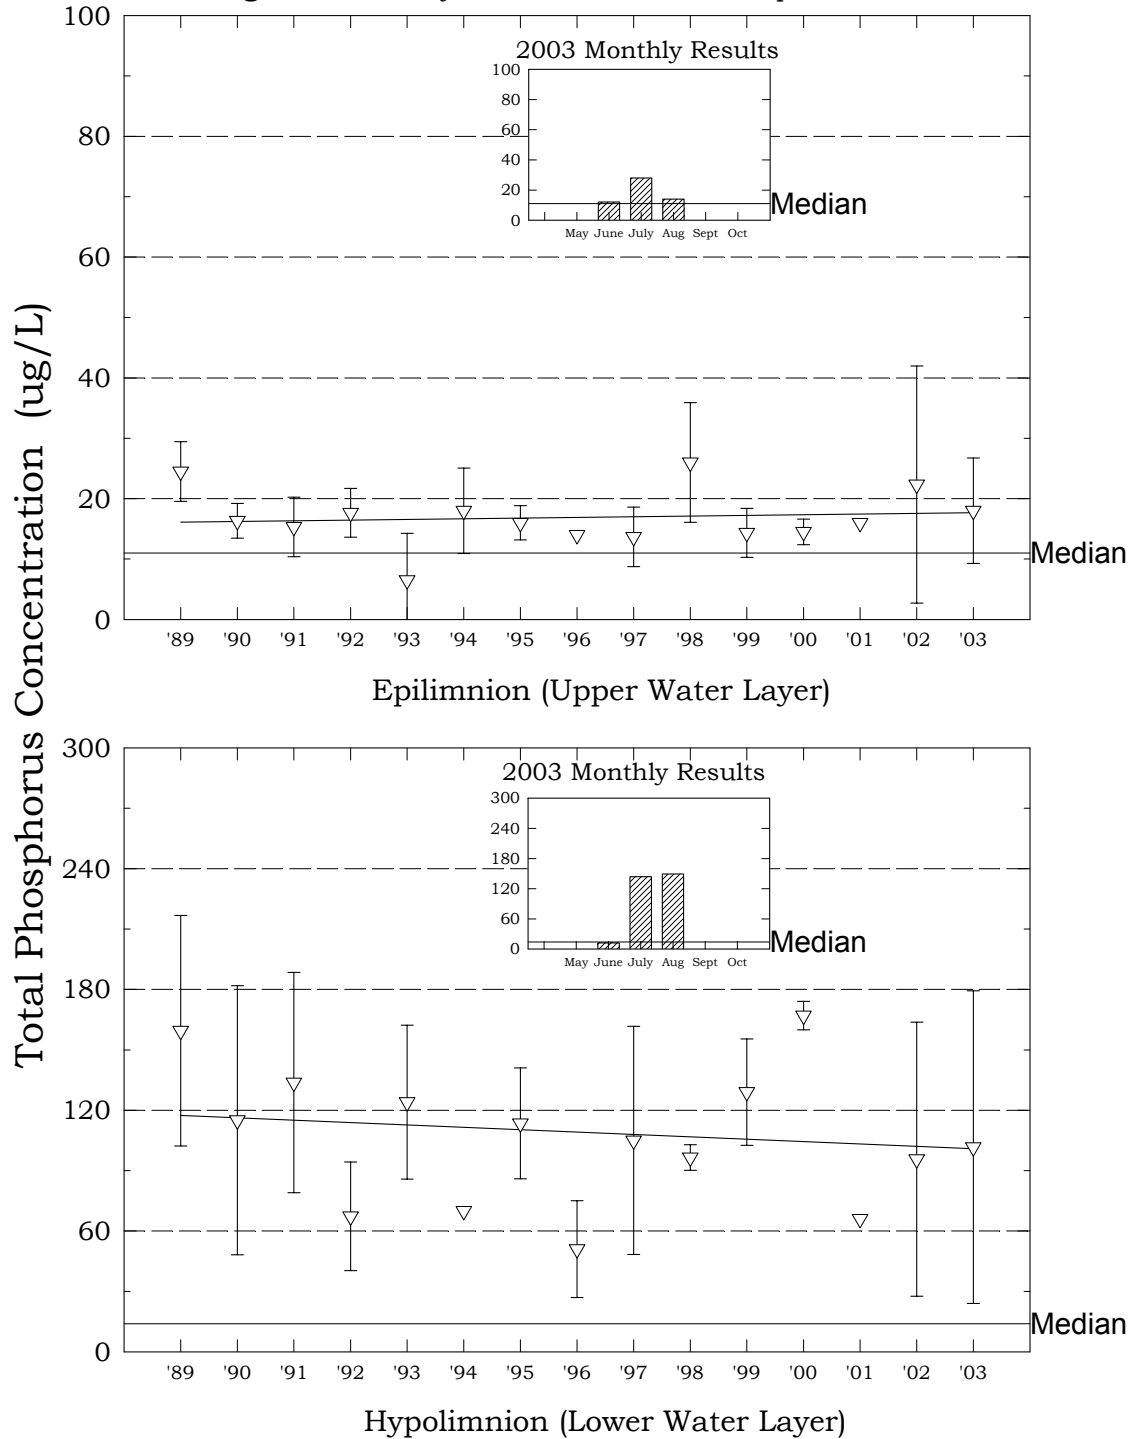
Figure 3. Monthly and Historical Total Phosphorus Data.

- **Figure 3 and Table 8:** The graphs in Figure 3 (Appendix A) show the amounts of phosphorus in the epilimnion (the upper layer) and the hypolimnion (the lower layer); the inset graphs show current year data. Table 8 (Appendix B) lists the annual maximum, minimum, and median concentration for each deep spot layer and each tributary since the lake/pond has joined the program.

The current year data for the epilimnion (the top inset graph) show that the phosphorus concentration **increased greatly** from June to July, and then **decreased greatly** from July to August. The phosphorus concentration on each sampling event was **greater than** the state median.

The current year data for the hypolimnion (the bottom inset graph) show that the phosphorus concentration **increased greatly** from June to July, and then **remained stable** from July to August. The phosphorus concentration in June was **approximately equal to** the state median, while the concentration in July and August was **much greater than** the state median.

It is important to point out that the turbidity of the hypolimnion (lower layer) sample was elevated on the **July** and **August** sampling events (21.1 and 29.7 NTUs respectively). This suggests that the lake/pond bottom may have been disturbed by the anchor or by the Kemmerer Bottle while sampling. When the lake/pond bottom is disturbed, sediment, which typically contains attached phosphorus, is released into the water column. When collecting the hypolimnion sample, please check to make sure that there is no sediment in the Kemmerer Bottle before filling the sample bottles.

Overall, visual inspection of the historical data trend line for the epilimnion show a **relatively stable** phosphorus trend, which is **slightly greater than** the state median.

Overall, visual inspection of the historical data trend line for the hypolimnion shows a **highly variable** phosphorus trend, which is **much greater than** the state median.

It is also important to point out that the phosphorus concentration in the hypolimnion has typically been ***much greater than*** the phosphorus concentration in the epilimnion. This data indicates that ***internal total phosphorus loading*** is occurring in the hypolimnion. (Please refer to the discussion of Table 9 and 10 for a detailed explanation of internal total phosphorus loading.)

One of the most important approaches to reducing phosphorus loading to a waterbody is to continually educate watershed residents about its sources and how excessive amounts can adversely impact the ecology and value of lakes and ponds. Phosphorus sources within a lake or pond's watershed typically include septic systems, animal waste, lawn fertilizer, road and construction erosion, and natural wetlands.
